Natural Propagation and Habitat Improvement

Volume II - Idaho

Final and Annual Reports, 1984

Lolo Creek Habitat Improvement

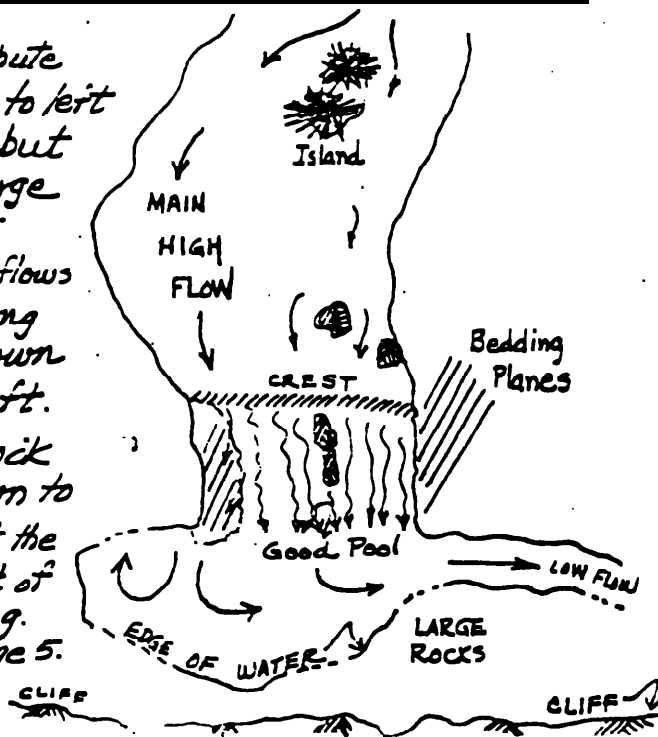
SITE No. 3 High velocity chute just upstream of 90° bend to left in Eldorado Creek. Small, but deep pool constricted by large rocks in deposition area at base of basalt cliff. High flows pass around large rocks along base of cliff as well as down low flow channel to the left. Bedding planes in chute rock and shore diagonal down to the right. A splash rock at the base of the chute (just left of center) may disorient leaping. Solutions are discussed on page 5.

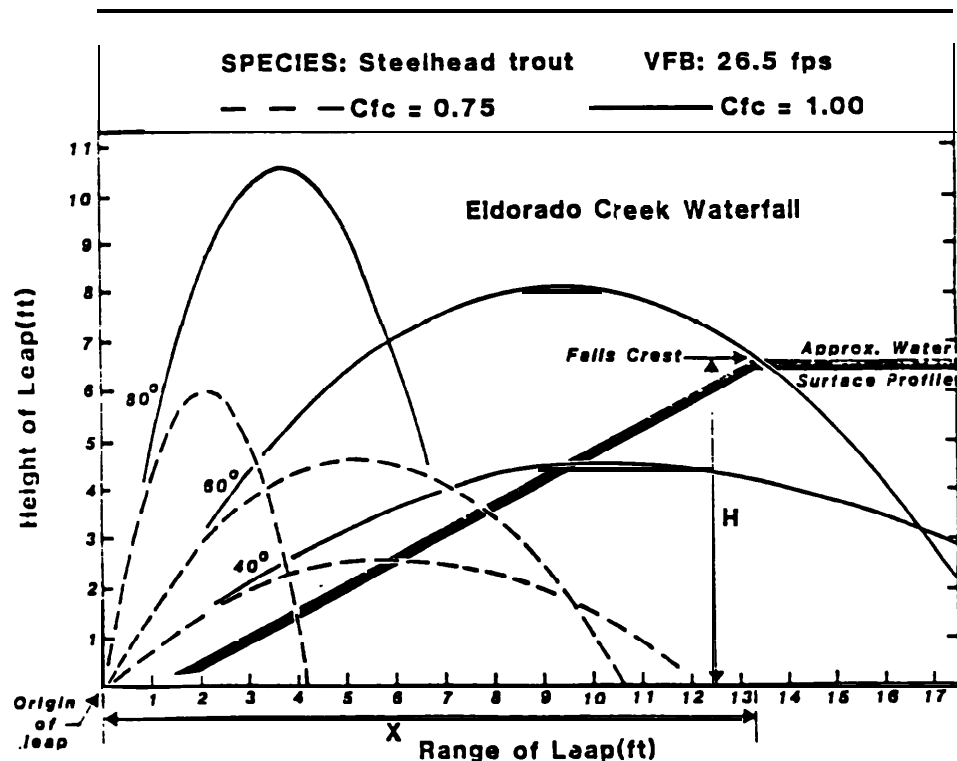
Figure 1. Eldorado Creek waterfall superimposed on steelhead leaping curves.

Powers<sup>(1)</sup> recently discussed the profile geometry of this Eldorado Creek barrier in his study of new methods for migration barrier analysis. Fig. 1 shows the profile with leaping curves for steelhead in different condition (nearness to being ripe). The "Condition of the fish" (Cfc) or coefficient of fish condition is related to an estimate of their capability to swim burst, prolonged and sustained speeds as related to the distance they have traveled from the ocean (nearness to spawning site), and the time to spawning. The two sets of curves, based on projectile body mechanics show that probably only the strongest steelhead (Cfc = 1.00) leaping at 60° would land near the crest and execute a successful passage. Some might be able to swim the last few feet if the discharge was large enough to provide adequate body depth.

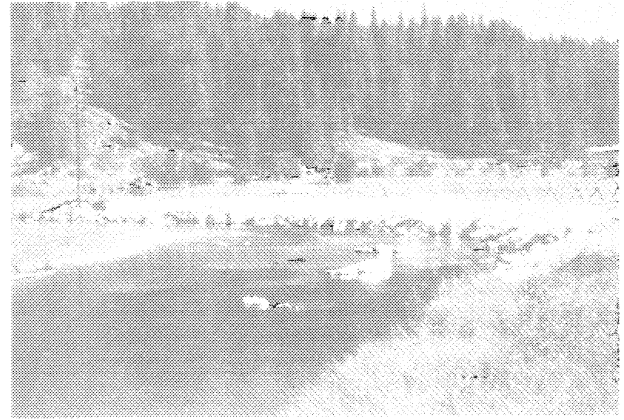
AFTER

Description - These eroding banks are 4'-6' and 12'-15' high. The erosion has resulted in a stream channel that is too wide and shallow, and there is no instream or bank cover. Erosion of the upstream bank is threatening to cause loss of the power line pole.

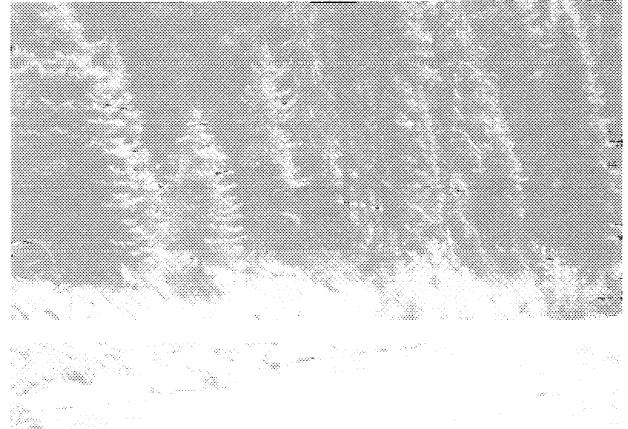
AFTER

Description - This 6'-15' eroding bank was caused by the stream being moved during dredging operations and is a constant sediment source. The stream was too wide and shallow, providing little, if any, fish holding habitat.

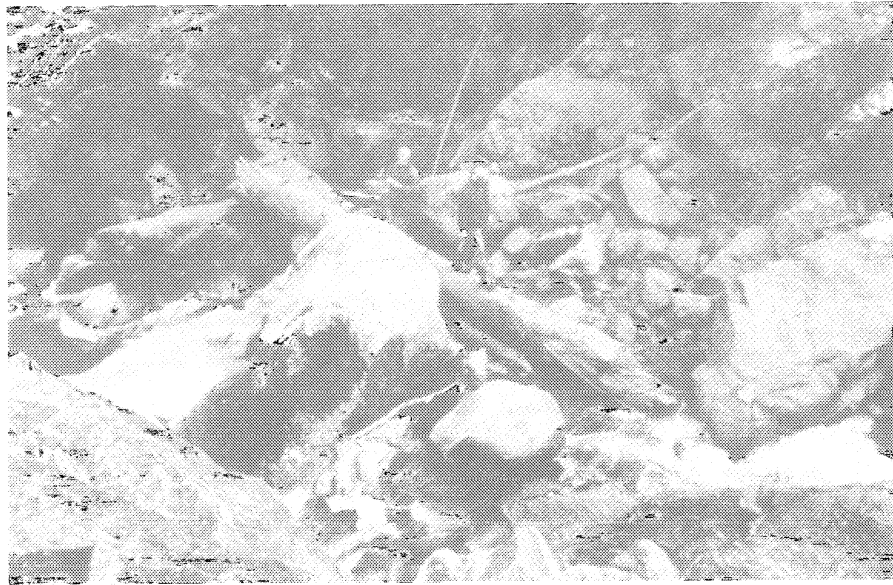
Photo 1-33 Barrier No. 3

After first shot. Note repositioned log.

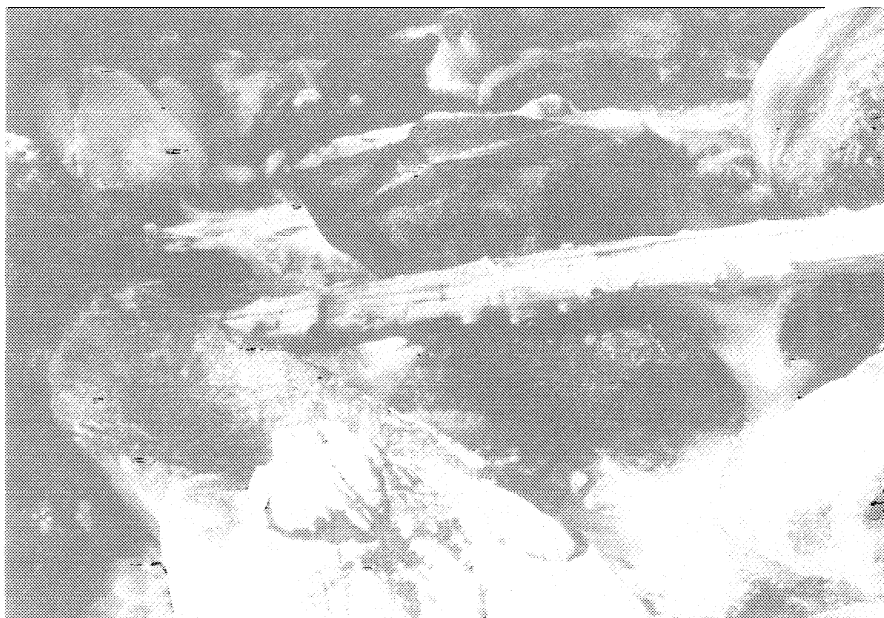
Photo 2-8 Barrier No. 1

Shows new access route on left with pool in lower right center. Auxiliary water flow shown entering on right.
